Kia Sorento - XMA

Glass Panel

Kia XMA (Sorento) - Glass Breakage

Field Incident Analysis Report 9th May 2014

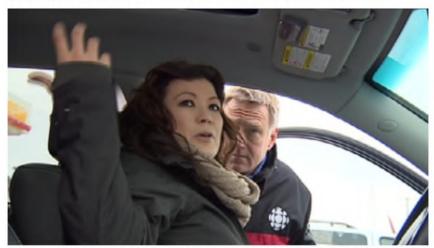
Kia Sorento owner Viola Stevens explains to Go Public's Mark Harvey what happened when her sunroof shattered while she was driving. (CBC)

Kia Canada replaced the sunroof under warranty at no charge to Stevens.

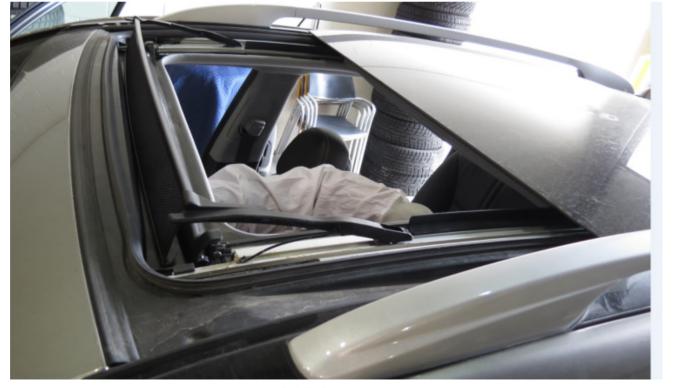
Moving Glass already replaced by **Dealer**

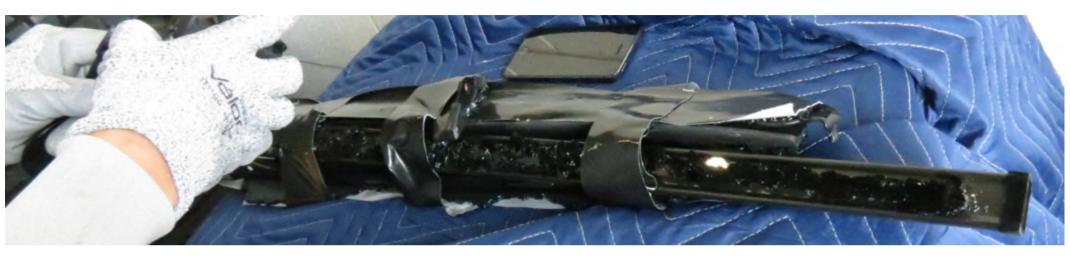
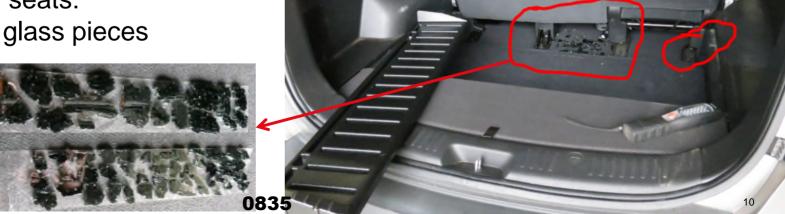
Items sent to KCI from Sandbury Dealer:

- Front cross car reinforcement bonded to glass
- 2 side sight shields taped to bottom of glass on outboard edges
- 2 side fame pieces main track/mechanism attachment bonded to glass
- 2 rear corner brackets idler link attachment bonded to glass

NOTE: Rear cross bar not present

Found under 2nd row seats:

Broken tempered glass pieces

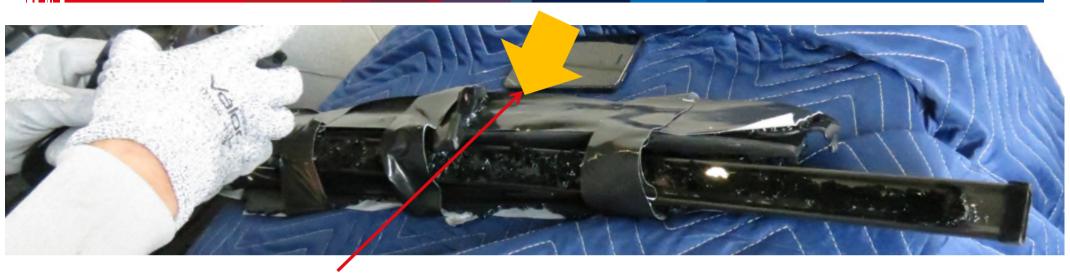
Suspected impact point is at the front of glass near the middle

Middle of bar

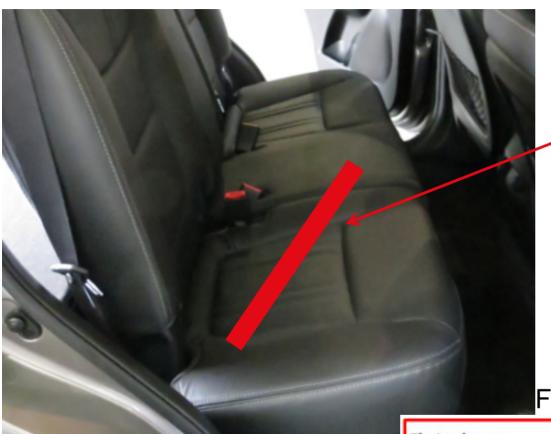
Approximate location of Front Cross Car Reinforcement after glass broke (per a picture viewed on George Bousioutis' computer at KCI).

The glass was closed with the sunshade open. The vehicle was traveling ~100Km/Hr and there were heavy wind gusts.

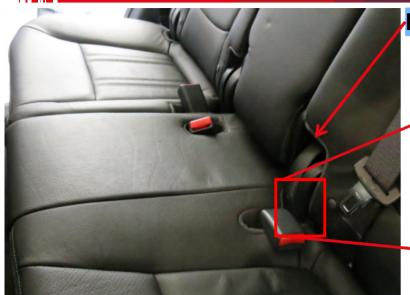
Possible Front Cross Car Reinforcement impact location

Possible Front Cross Car Reinforcement contact with seat

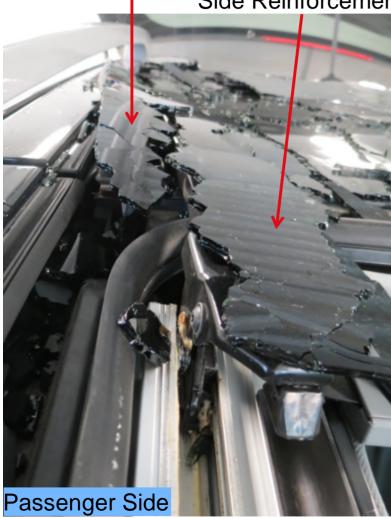
Taped on Sight Blind-loose

Side Reinforcement

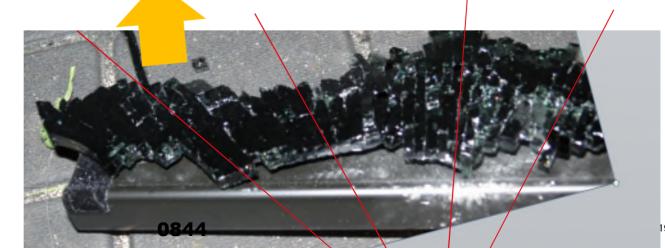
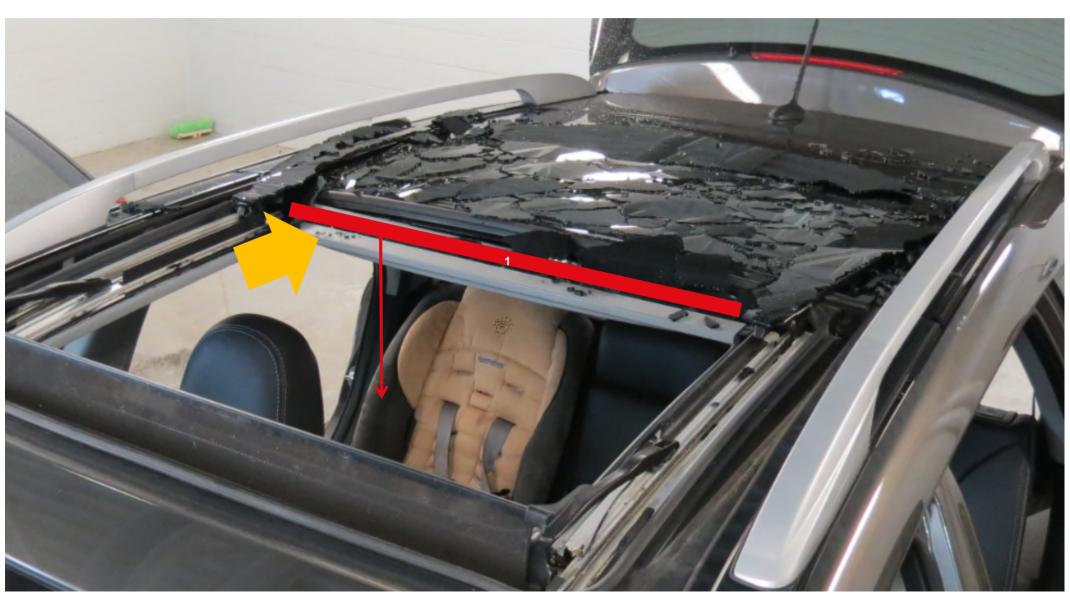
Suspected travel path of Front Cross Car Reinforcement

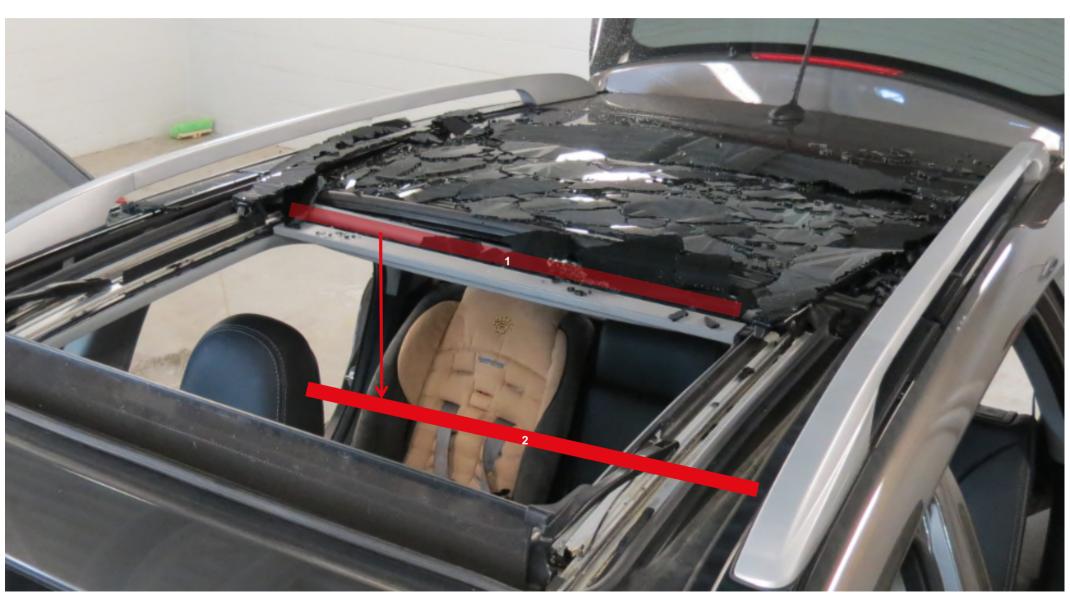
Suspected travel path of Front Cross Car Reinforcement

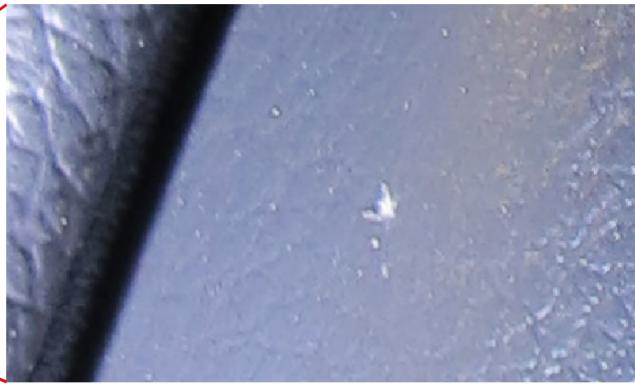
Suspected travel path of Front Cross Car Reinforcement

Reinforcement falls after impact and contacts fully upward headrest. The reinforcement's velocity from the impact and 60km/hr vehicle speed cause the driver's side of the reinforcement to twist rearward. The reinforcement ends up in the cargo area 180 degrees from it's installed orientation.

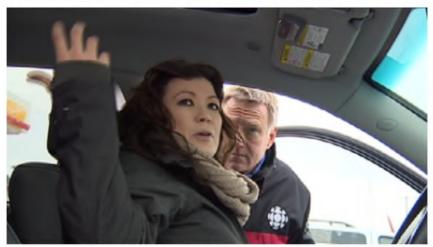
Kia Sorento owner Viola Stevens explains to Go Public's Mark Harvey what happened when her sunroof shattered while she was driving. (CBC)
